**Report of Dr. Brenton Cox
Regarding the May 31, 2017
Explosion at Didion Milling in
Cambria, Wisconsin**

March 31, 2023

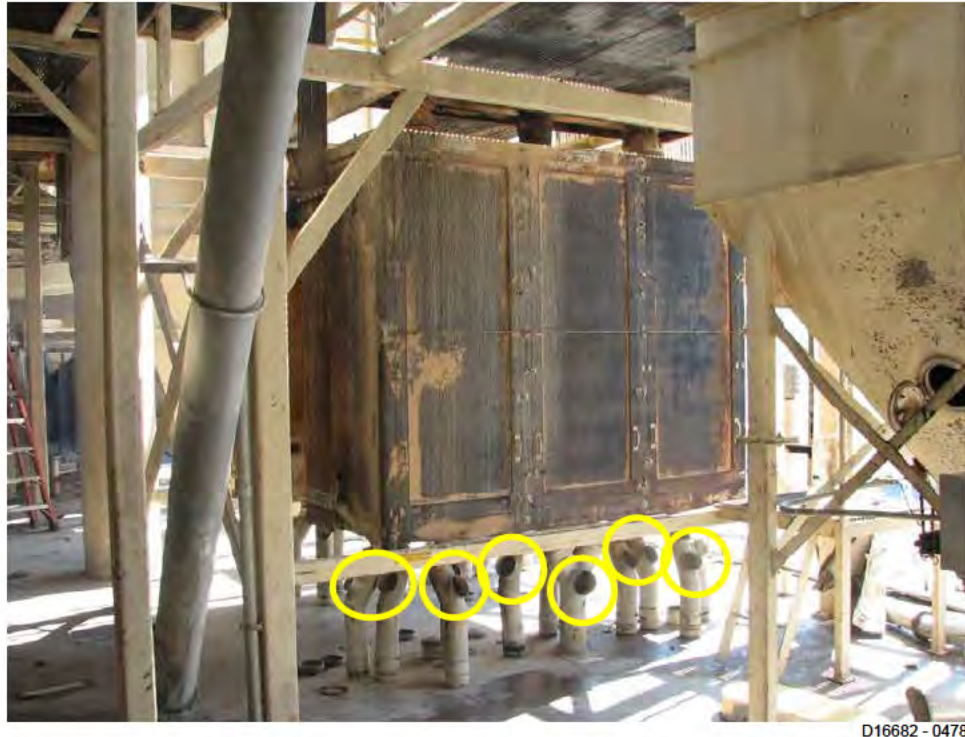
Figure 65. Post-incident view of the 6-Section Bran Sifter on the 4th floor of B-Mill with detached caps as a result of internal overpressure.

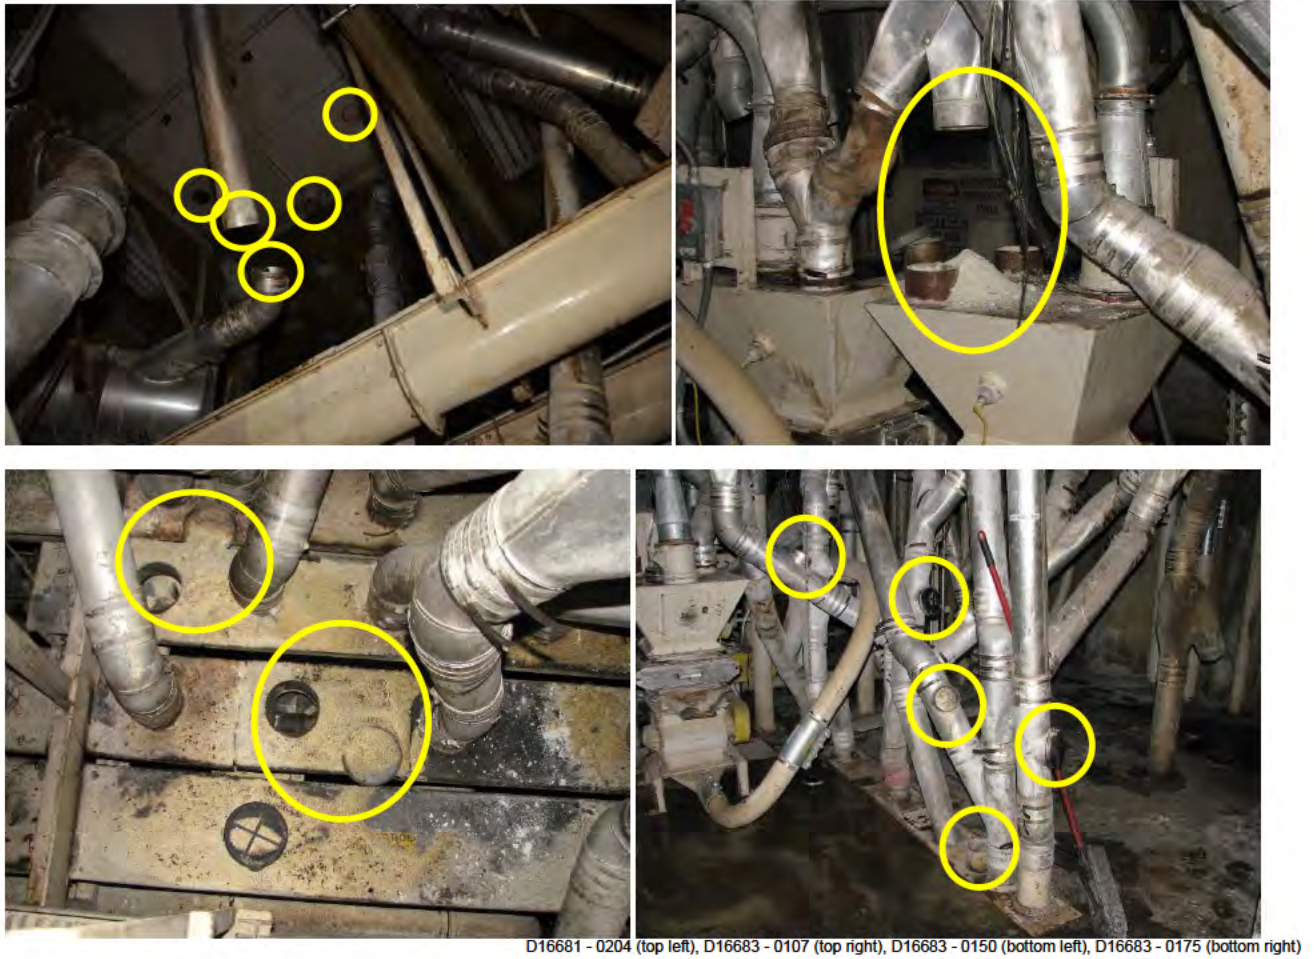
Figure 67. Post-incident view of separated ducts and detached caps in A2 as a result of internal overpressure. Material was apparently ejected from these openings as a result.

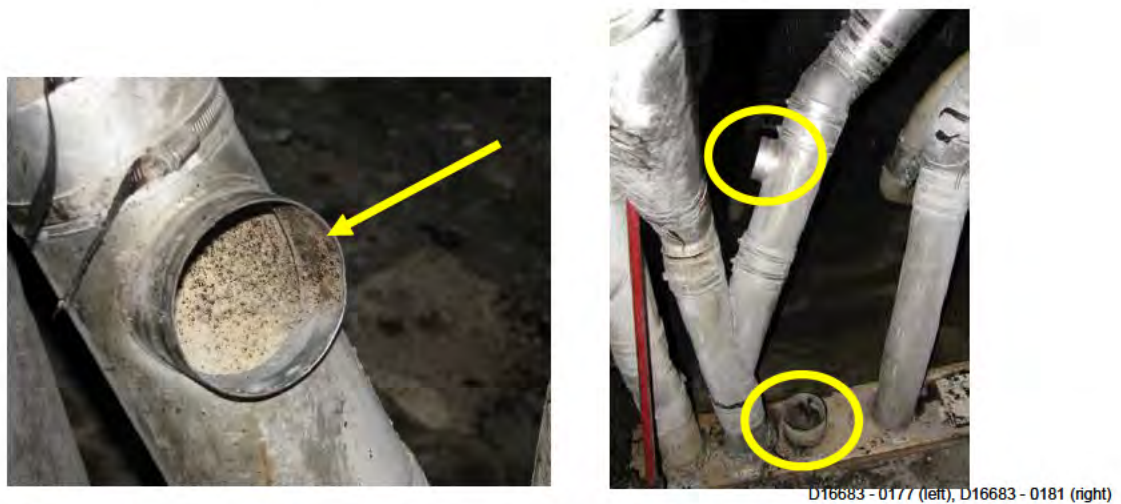
Figure 68. Post-incident view of burned grain inside ducting in the A-Mill (2nd floor).

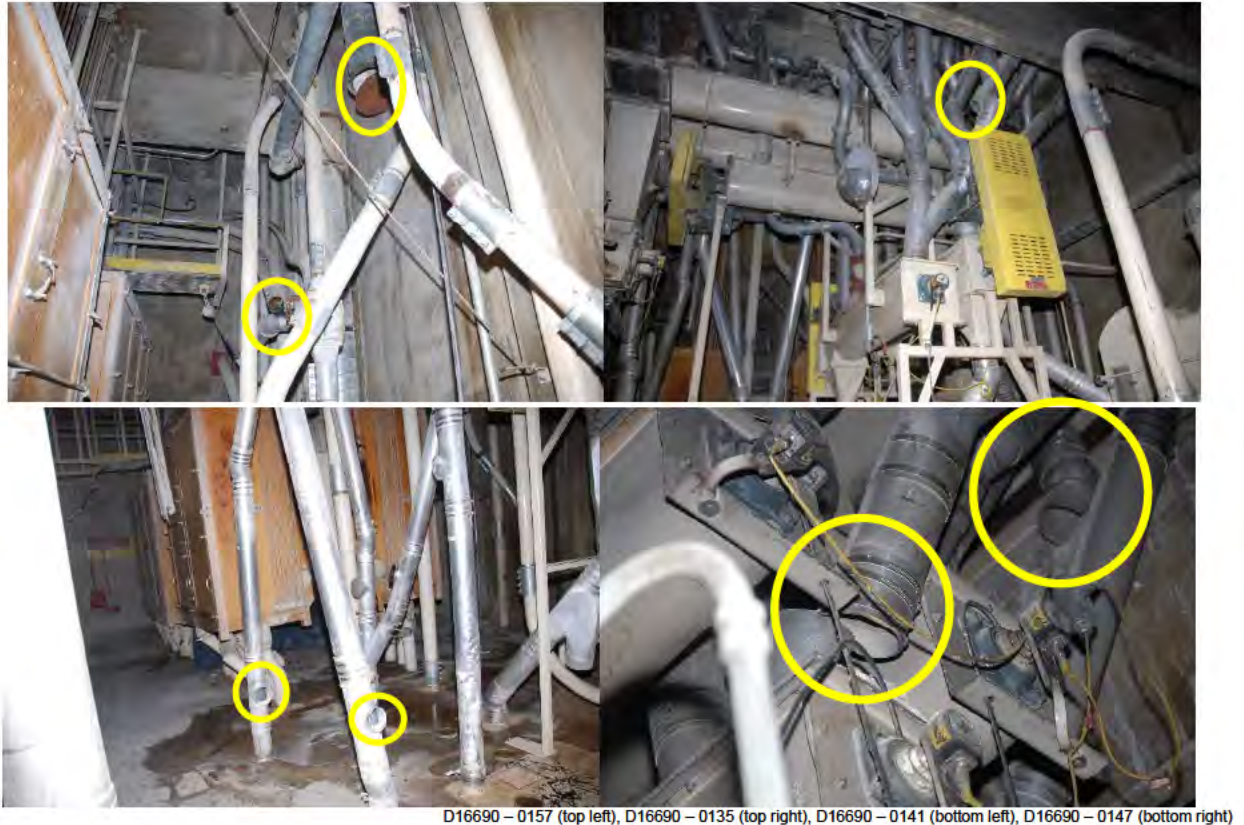
Figure 70. Post-incident view of process lines that have been separated or had their flanges or caps blown off by the event in the A-Mill (3rd floor).

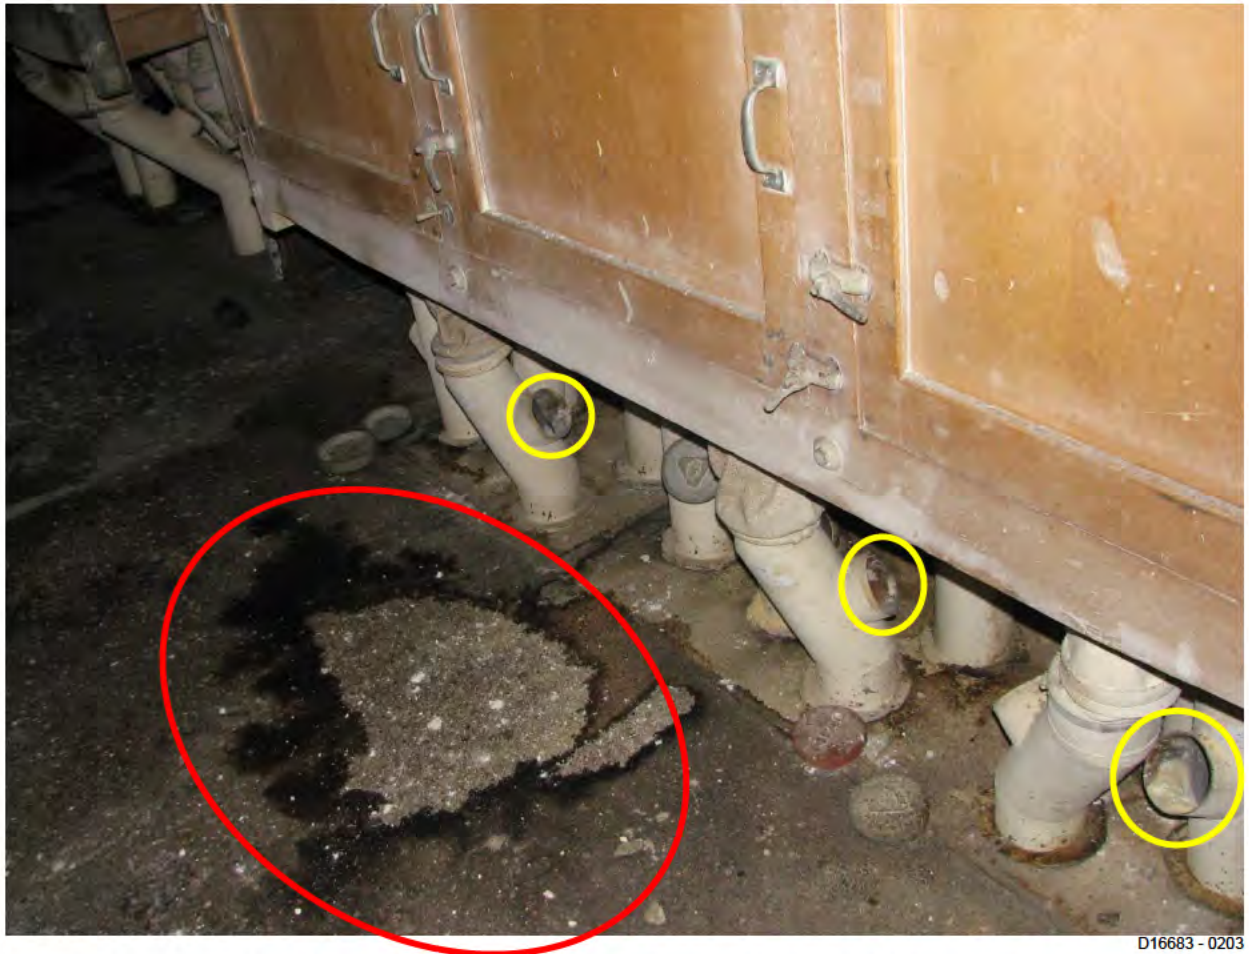
Figure 71. Post-incident view of 6-Section Sifter on 3rd floor of A-Mill with clear burn patterns on the ground and caps blown off ducts below the sifter going into the 2nd floor of the A-Mill.

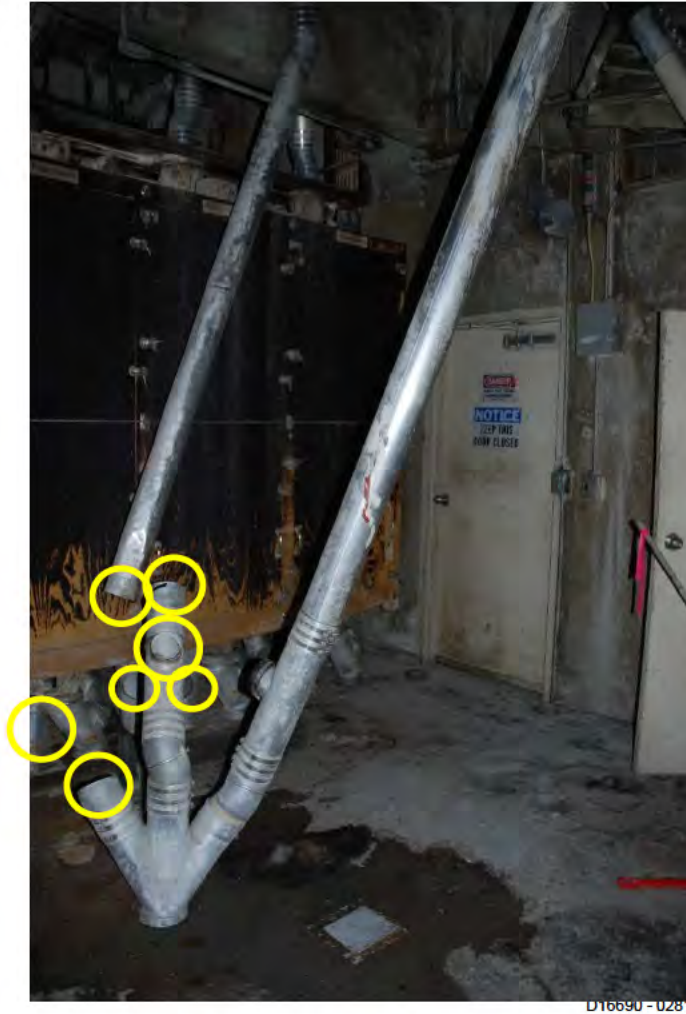
Figure 72. Post-incident view of the Grit/Flour Sifter (M-11021) on the 5th floor of the A-Mill. Yellow circles indicate detached ducts and caps as a result of internal overpressure.

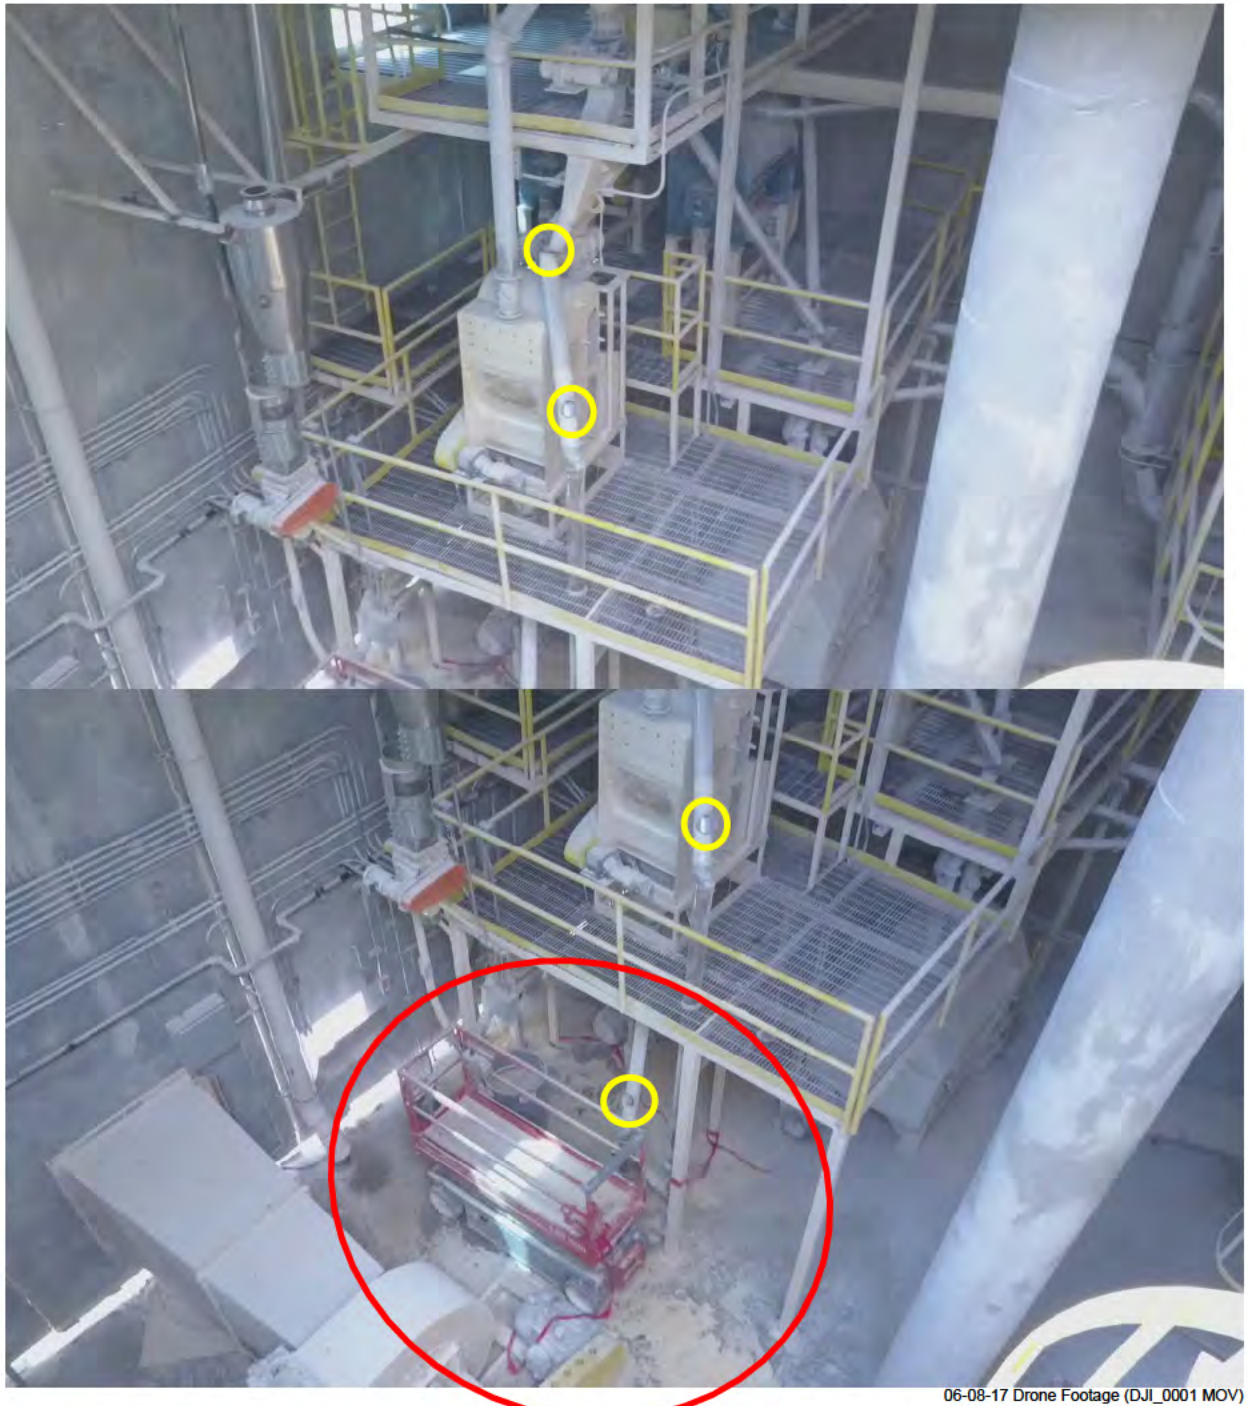
Figure 74. Post-incident aerial view of ejected grain products (red) attributable to separated ducts (yellow), both of which are indicative of internal overpressure in the D-Mill.

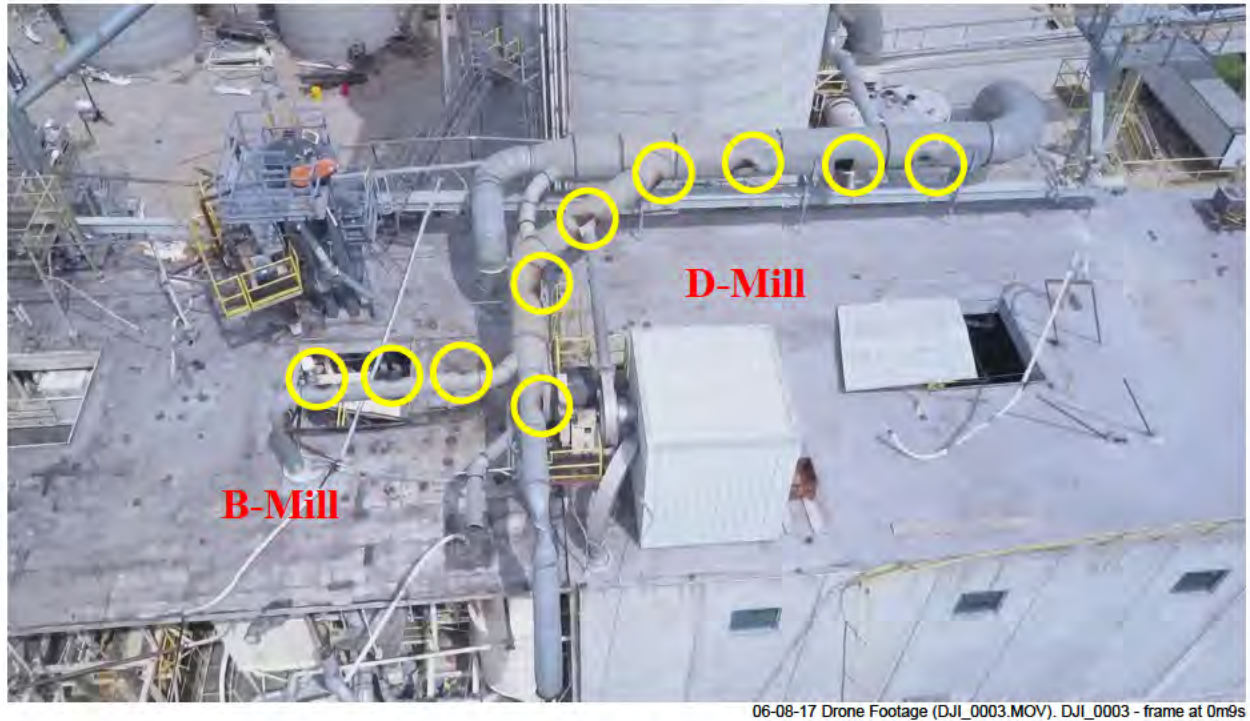
Figure 86. Post-incident aerial view of ducting connecting the B- and D-Mill to the Dry Grit Filter.

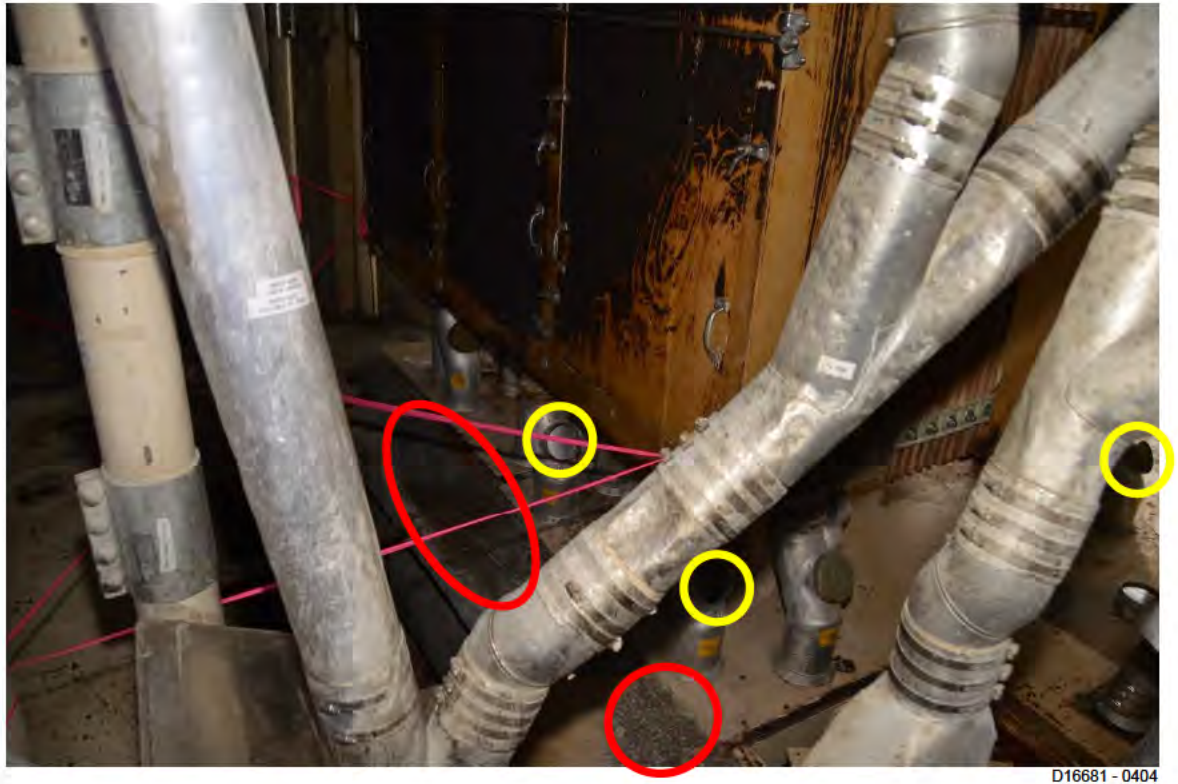
Figure 89. Post-incident view of A-Mill Sizing 6-section sifter (M-11014) on the 4th floor of the A-Mill with caps blown off due to internal pressure (yellow) and burns on the floor from ignited ejected product (red).

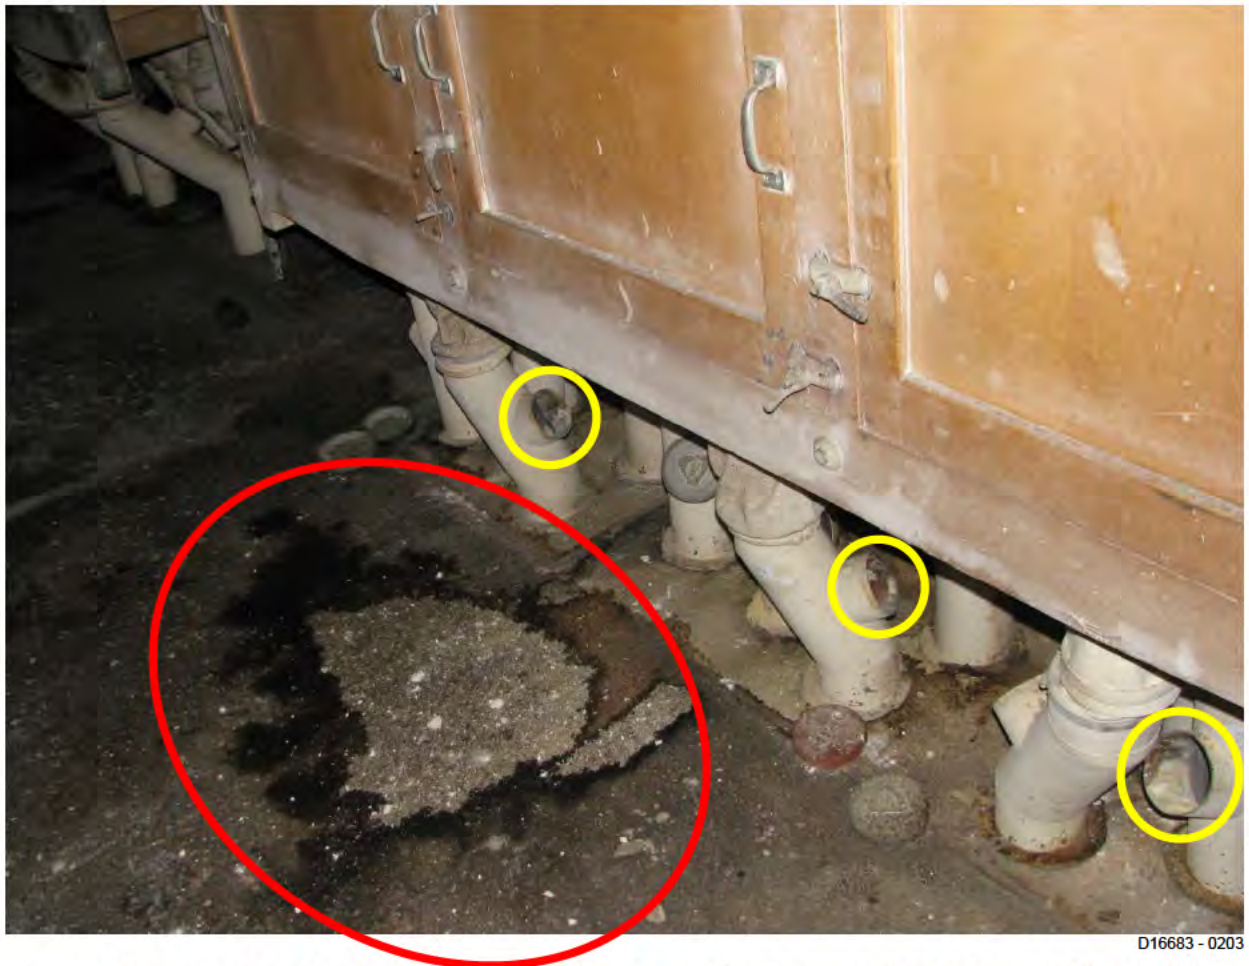
Figure 90. Post-incident view of Sizing Flour 6-Section Sifter on the 3rd floor of the A-Mill with caps blown off due to internal pressure (yellow) and burns on the floor from ignited ejected product (red).

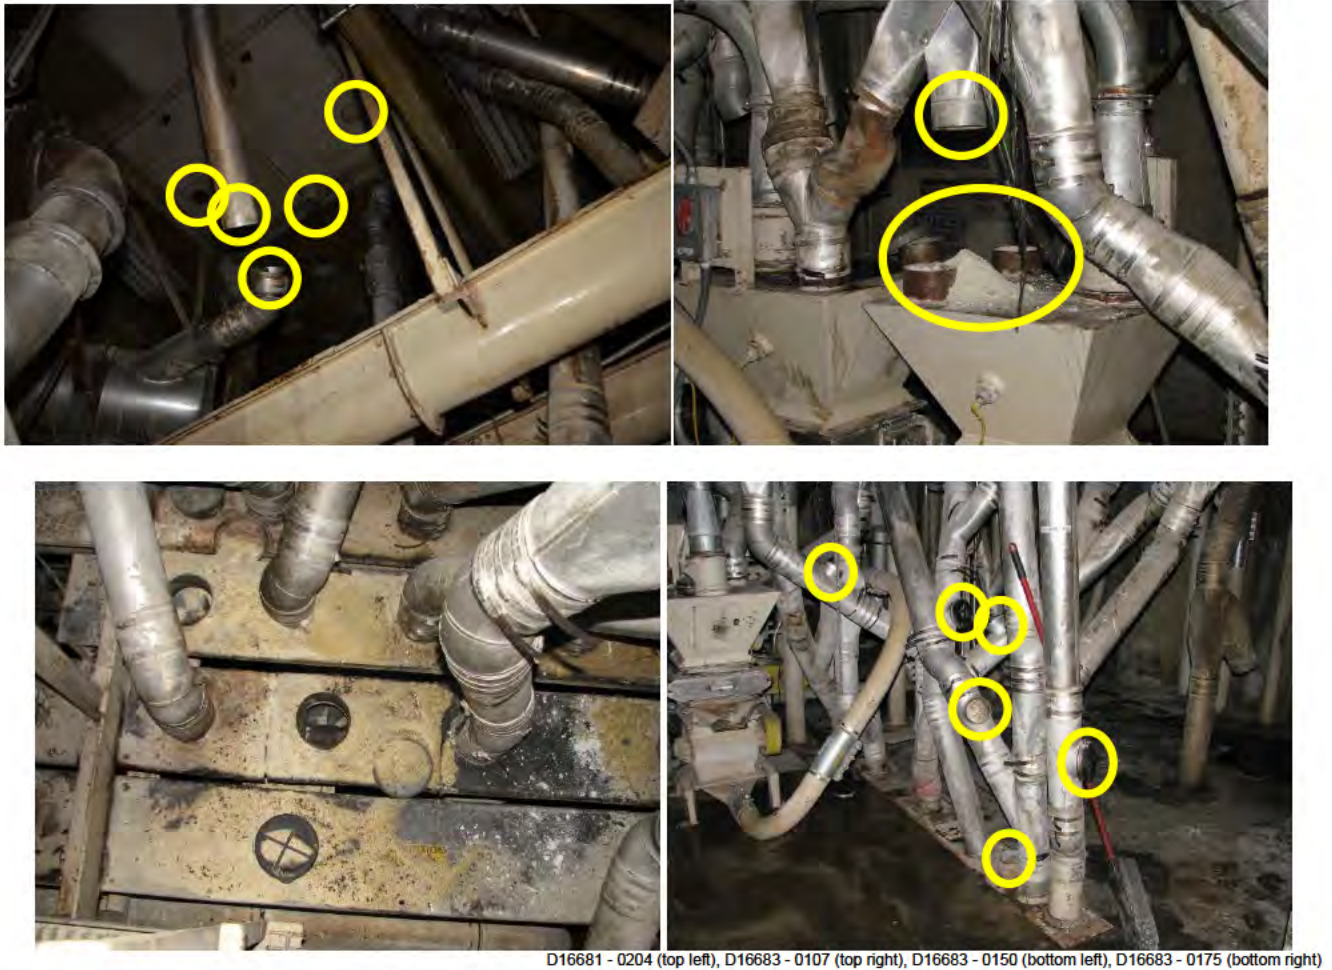
Figure 91. Post-incident view of A-Mill observations of separated ducts or caps blown off due to internal overpressure (2nd floor).

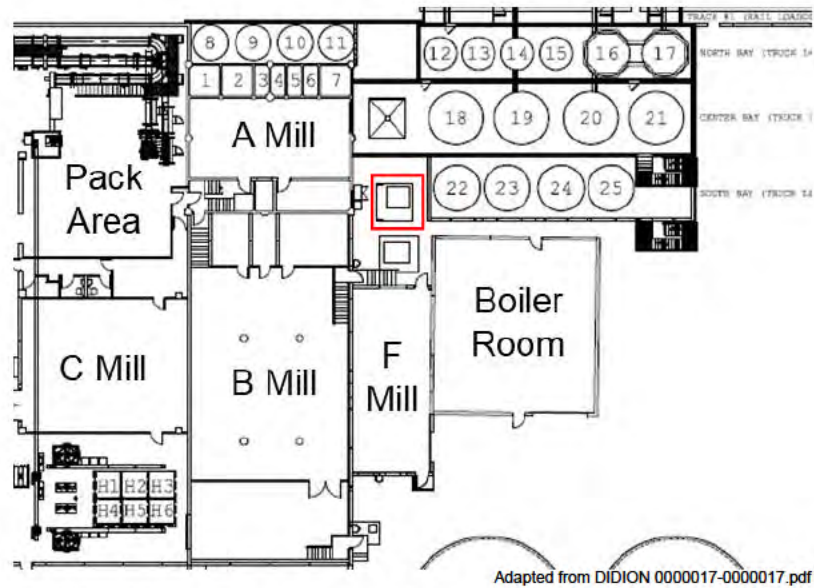
Figure 102. The transformer that was damaged in the explosion was located in a courtyard between the mill buildings and truck loading area, shown in red.

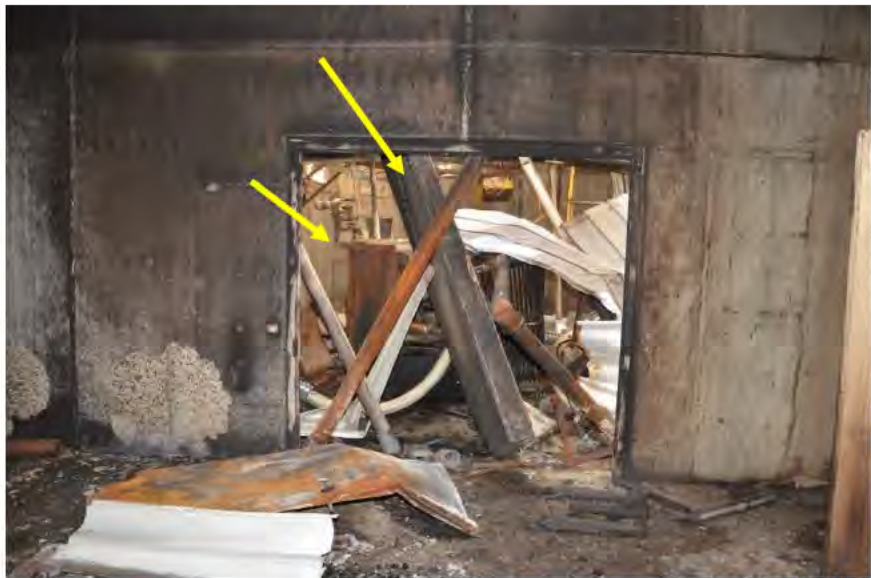
Figure 103. Transformer that was impacted by a panel that most likely fell from the B-Mill, resulting in a fire involving transformer oil. Yellow arrows indicate the locations of the panel and transformer.
